INDUSTRIAL EQUIPMENT SURVIVAL/RECOVERY FEASIBILITY PROGRAM DURING EVENT DICE THROW

The Boeing Company
P.O. Box 3707
Seattle, Washington 98124

31 December 1976

Final Report

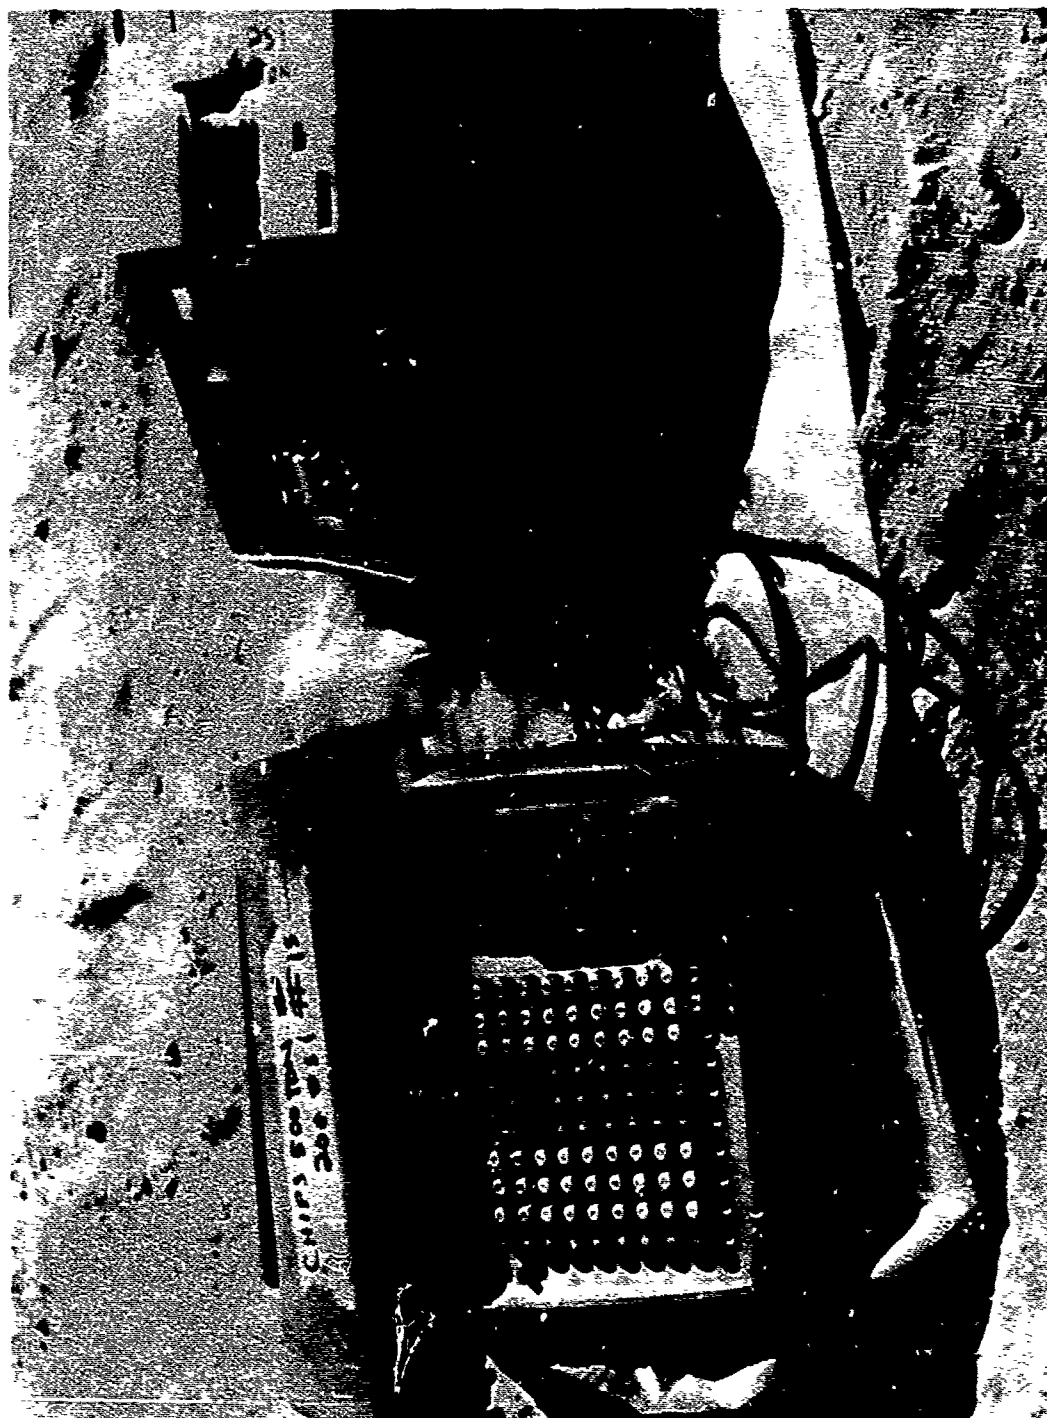
FIGURE 13: PROTECTIVE EFFECTS OF USING METAL CHIPS. CALCULATOR ON LEFT WAS PROTECTED WITH CHIPS. CALCULATOR ON RIGHT WAS NOT.

At 200 psi (Table 3) all desk calculators were packed in chips in garbage cans. Not enough rattle space was obtained between the ends of the carriages and the sides of the garbage cans to provide protection. All of these calculators were damaged with only two (items 4 and 14) deemed to be repairable. Item 4 was placed in the bottom of the 7 ft. trench. The other calculators were placed at various depths down a ramp at one end of the trench. With one exception, item 14, there was not enough spacing between cans to provide adequate arching. The result was a "channel of destruction". Item 14 was placed somewhat to one side of this channel, so received less damage. Figure 13 shows the two shallowest calculators at 200 psi (items 15 and 16). The unprotected calculators on the right clearly received more damage than the left calculator which was in chips.
